Flood Control Project Maintenance
2018 Structure Summary Report
Overall Unit and Item Ratings

Plumas County

North Fork Feather River Diversion Channel Drop Structure No. 1

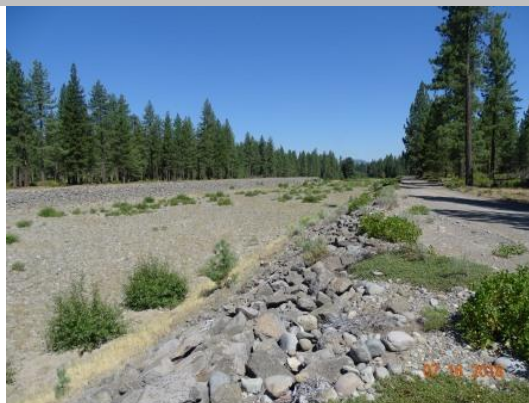
Photo 1 of 4 : ST_2018_NA0015_57_23_20180724_00005.jpg

View looking upstream from Drop Structure 1, 2018.

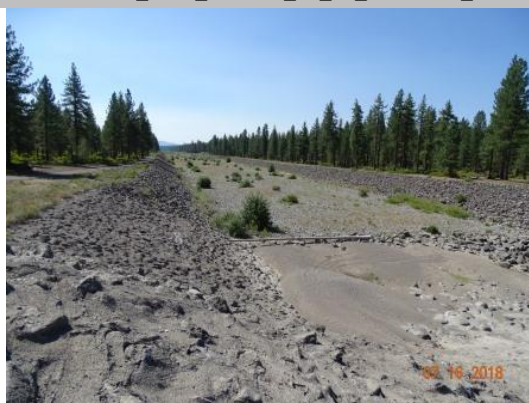
Photo 2 of 4 : ST_2018_NA0015_57_23_20180724_00006.jpg

View looking downstream from Drop Structure 1, 2018.

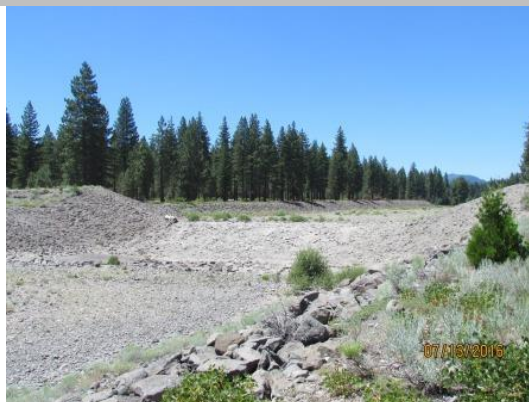
Photo 3 of 4 : ST_2018_NA0015_57_23_20180723_00004.jpg

View of drop structure 1, looking towards the North Fork Feather River.

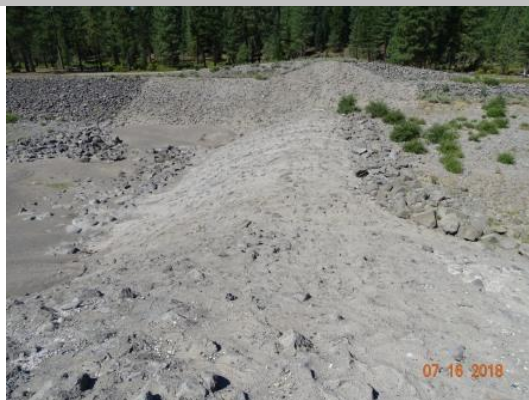
Photo 1 of 1 : ST_2018_NA0015_57_4_20180724_00007.jpg

View looking across the drop structure from the left bank at the well maintained concreted revetment, 2018.

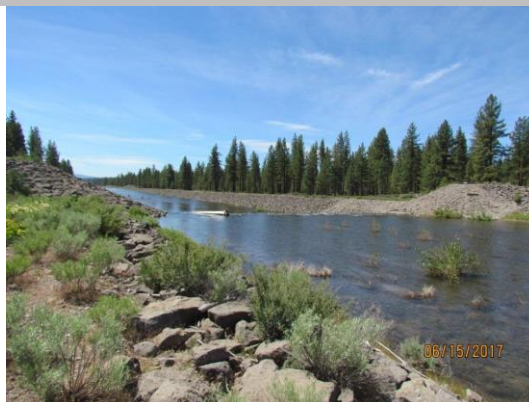
Photo 3 of 4 : ST_2018_NA0015_58_23_20180723_00001.jpg

View of drop structure 2, with water flowing over the structure during the inspection.

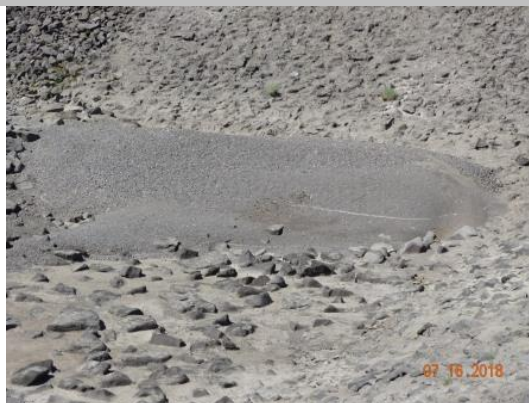
Photo 1 of 1 : ST_2018_NA0015_60_2_20180724_00006.jpg

View of the right side of the channel at a small build up of sedimentation, 2018.

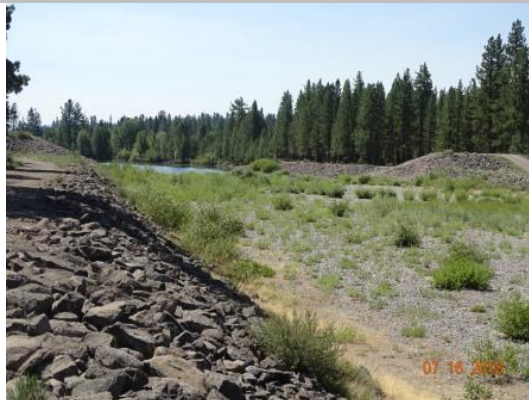
Photo 1 of 1 : ST_2018_NA0015_63_1_20180802_00008.jpg

Vegetation in channel near structure should be removed.

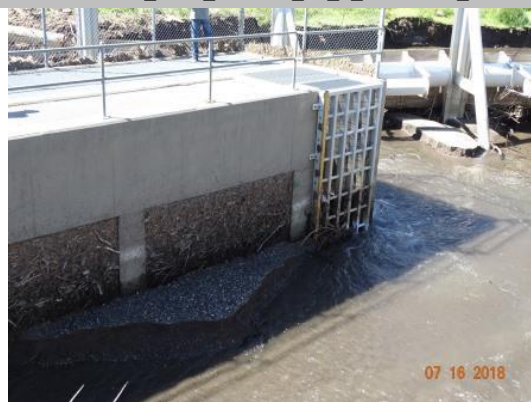
Photo 1 of 1 : ST_2018_NA0015_37_2_20180725_00027.jpg

View of the build up of sedimentation and debris at the fish ladder intake, 2018.

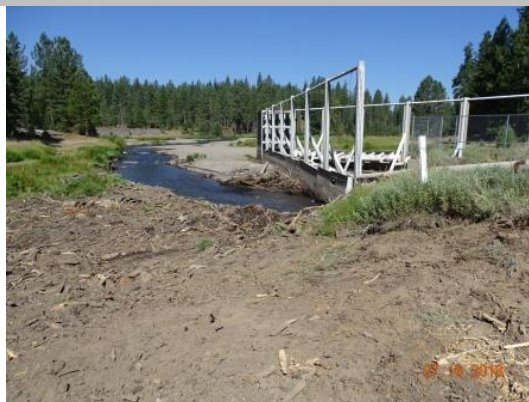
Photo 1 of 3 : ST_2018_NA0015_37_5_20180725_00025.jpg

View of the debris at the diversion intake structure south side, most of the debris was removed, but the District could not reach it all due to the meandering of the river, 2018.

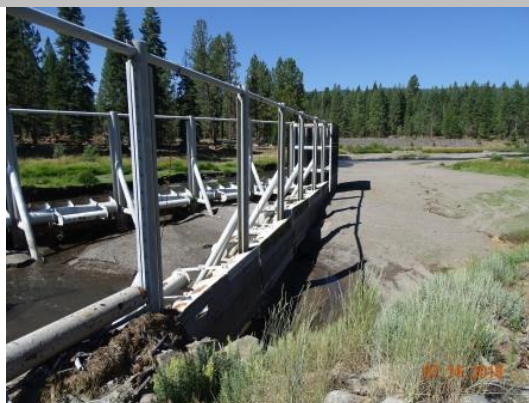
Photo 2 of 3 : ST_2018_NA0015_37_5_20180725_00026.jpg

View of the diversion intake structure, north side with no debris present, 2018.

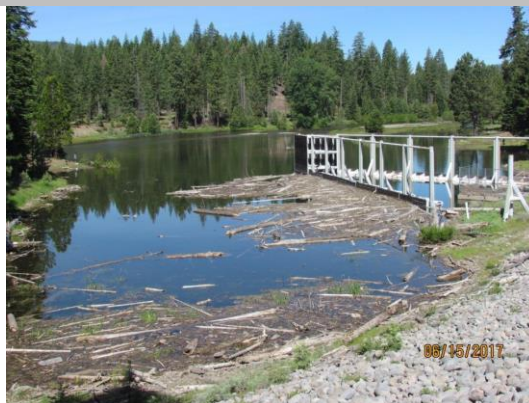
Photo 3 of 3 : ST_2018_NA0015_37_5_20180723_00002.jpg

View of the high water and debris at the diversion intake structure (2017).

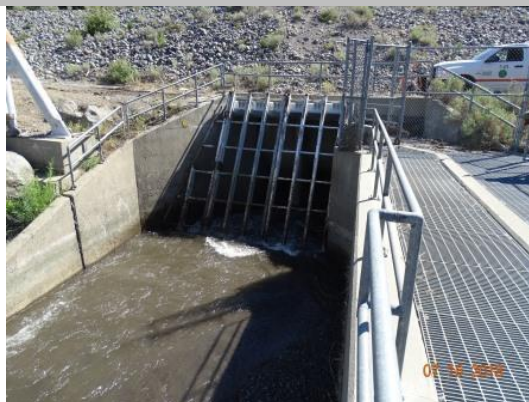
Photo 1 of 2 : ST_2018_NA0015_37_9_20180725_00023.jpg

View of the clean trash rack, 2018.

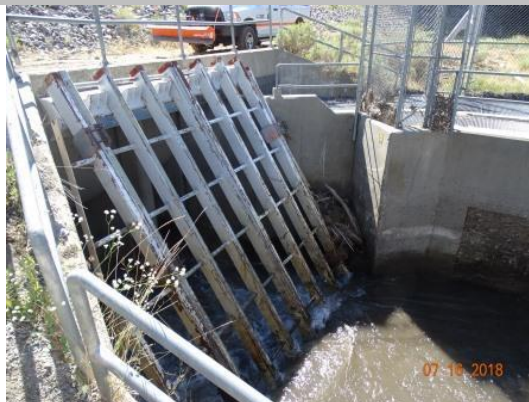
Photo 2 of 2 : ST_2018_NA0015_37_9_20180725_00024.jpg

Second view of the clean trash rack, 2018.

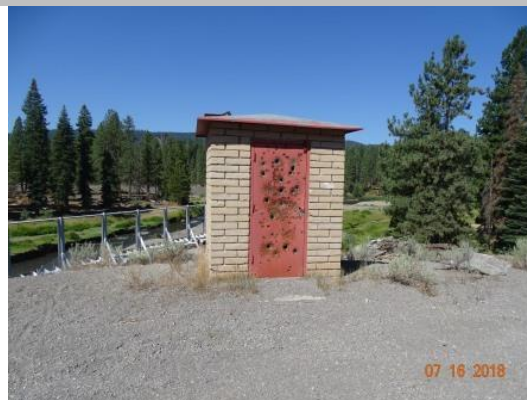
Photo 1 of 1 : ST_2018_NA0015_37_12_20180725_00020.jpg

Gauging house on top of dam, no longer used due to vandalism, 2018.

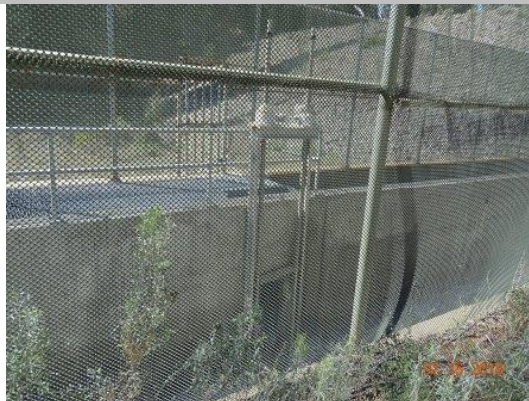
Photo 1 of 2 : ST_2018_NA0015_37_13_20180725_00022.jpg

View of the manual screw gates for the fish ladder on the outfall structure, 2018.

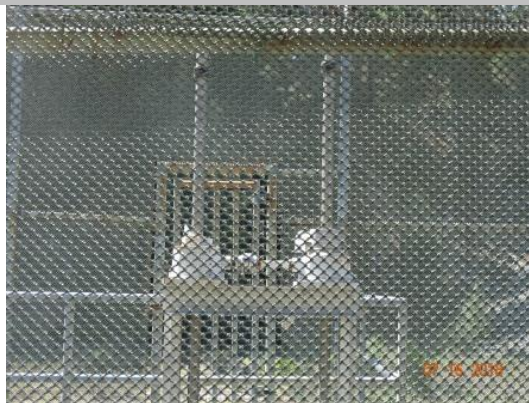
Photo 2 of 2 : ST_2018_NA0015_37_13_20180725_00021.jpg

Closer view of the manual screw gates for the fish ladder on the outfall structure, 2018.

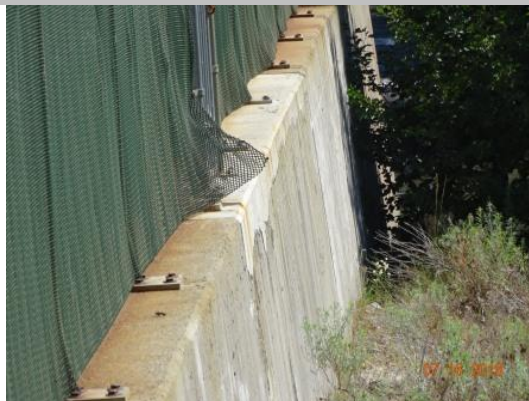
Photo 1 of 1 : ST_2018_NA0015_37_14_20180725_00019.jpg

LM Start	0.00	Rating **	A	Issue No.	14
LM End	0.00	Issue Type +	Ma	Location *	
Category	Structures & Concrete Lined Channels	GPS Latitude/Longitude			
		Start	End		
Item	Concrete Surfaces	40.302834 °		40.302834 °	
		-121.261901 °		-121.261901 °	
DWR ID	DWR_NA0015_37_t_2012_14				
Action/Comments					
Inspector Comments: There is minor spalling and cracking that Plumas County repaired on the south wall of the outfall structure, 2018.

View of the concrete spalling repair on the south wall of the outfall structure, 2018.

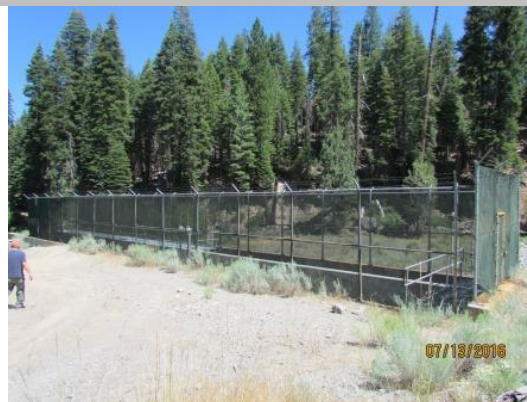
Photo 1 of 3 : ST_2018_NA0015_37_17_20180723_00009.jpg

View of the security fencing around the outfall.

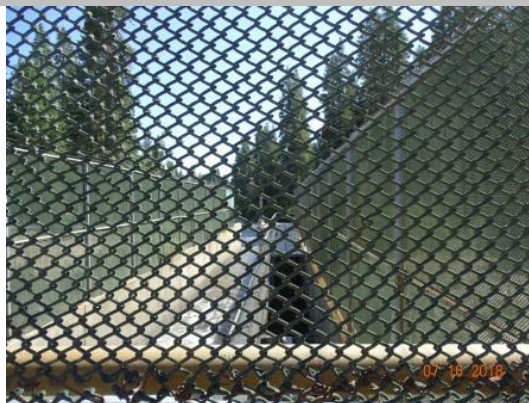
Photo 2 of 3 : ST_2018_NA0015_37_17_20180725_00018.jpg

Closer view of the security fencing around the outfall, 2018.

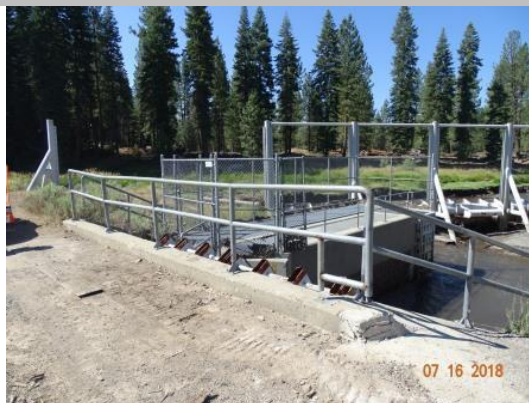
Photo 3 of 3 : ST_2018_NA0015_37_17_20180725_00017.jpg

View of the security fencing around the fish ladder, 2018.

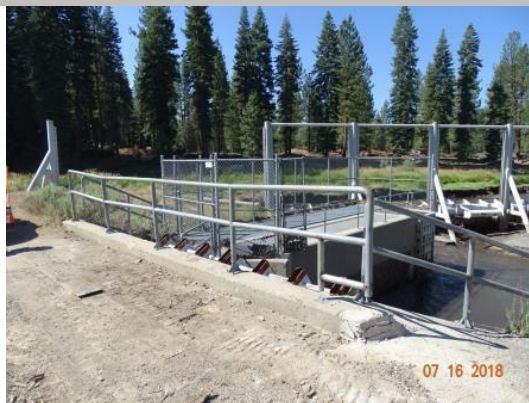
Photo 1 of 1 : ST_2018_NA0015_37_22_20180725_00016.jpg

View of the hand rail around the inlet and fencing around the fish ladder for safety & fall protection, the outlet also has security fence around the structure, 2018.
